GEORGIA DEPARTMENT OF NATURAL RESOURCES

Air Protection Branch

PM 2.5 Network

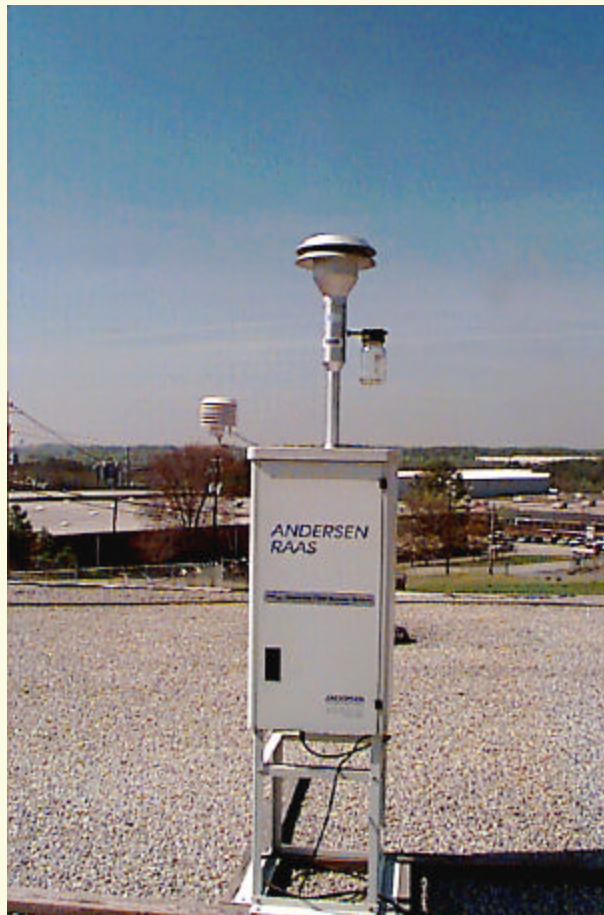
We received the Andersen RAAS Sequential monitors.

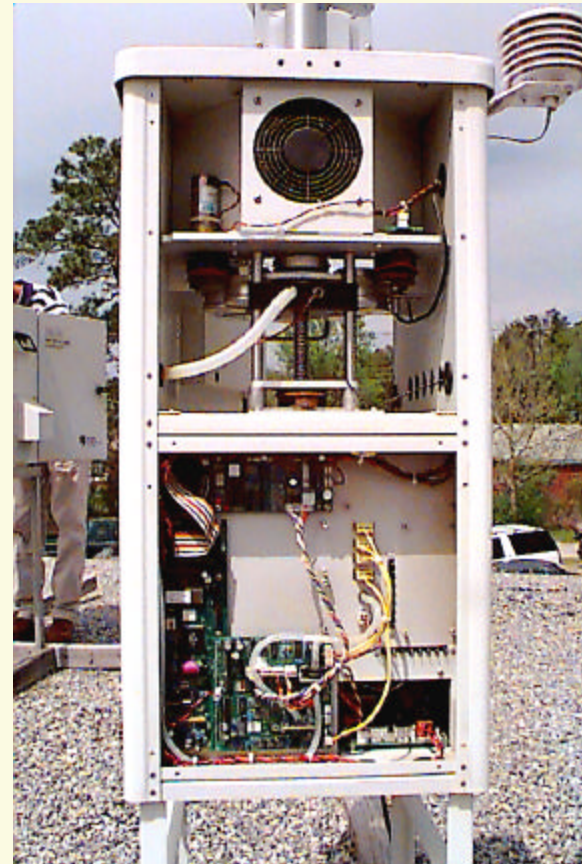
Vertical Encoders

- 4 The Vertical encoder drives and removes the filter cassette into the WINS Impactor.

- 4 So far about 30 % of our vertical and horizontal encoders have failed and had to be replaced.
- 4 The vendor is being very helpful in heading this problem off before we encounter any more.

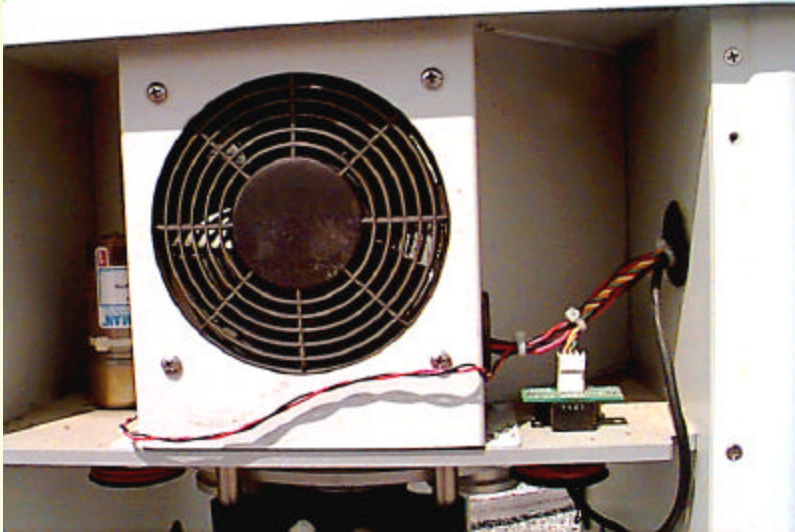
- 4 The Horizontal Encoder rotates the carousel tray to the proper position.

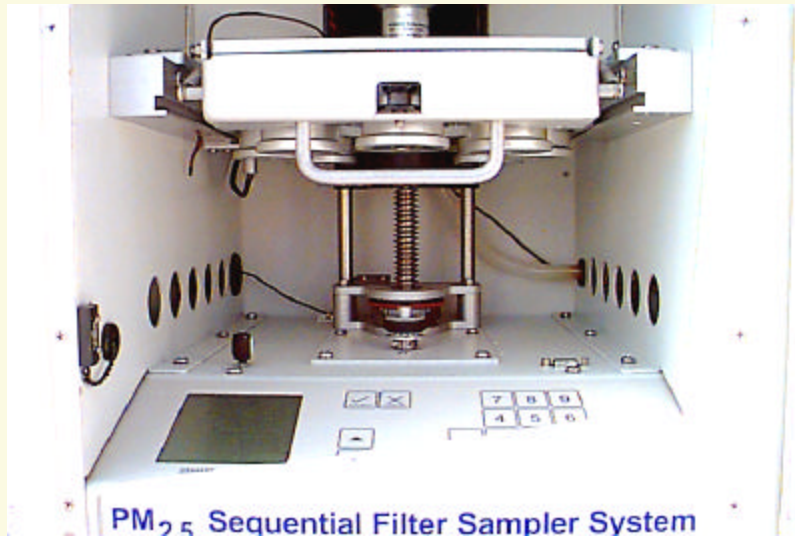
A better shot of the carousel

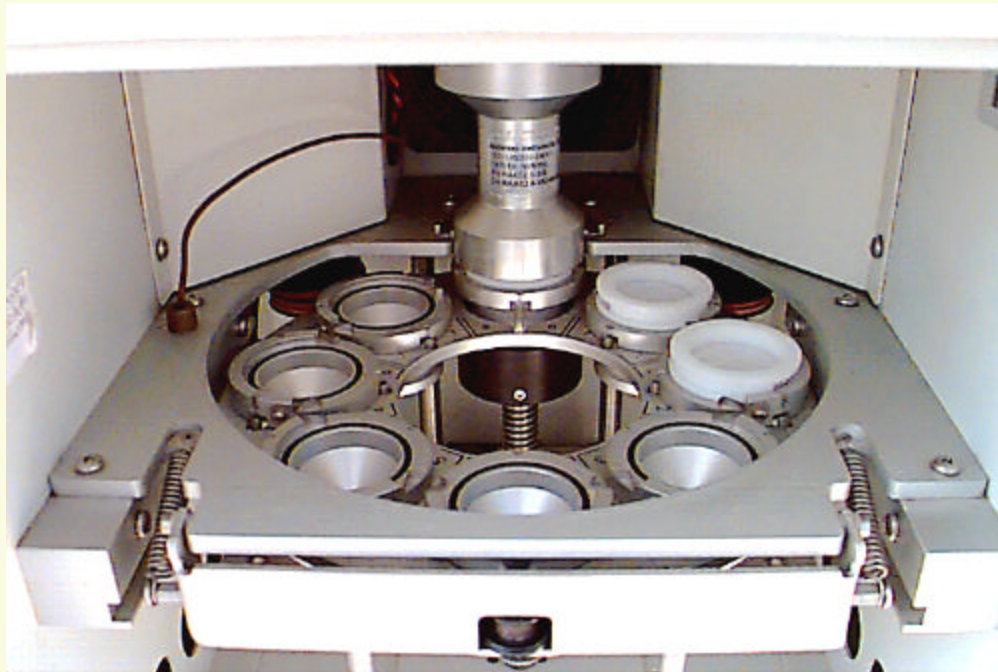
Drive Belts

4 There are a number of drive belts that move the carousel and the vertical shaft that puts the filter into place. If an encoder goes bad, and locks up a part, these belts can wear out quickly.

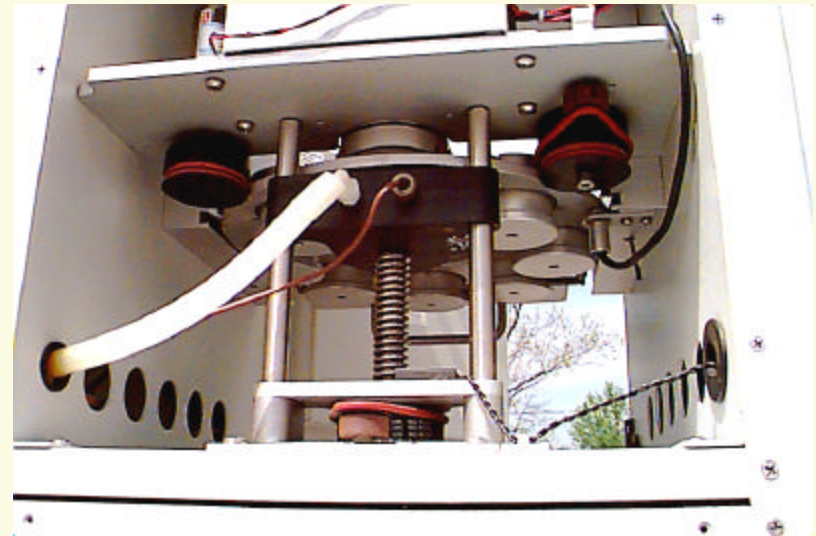
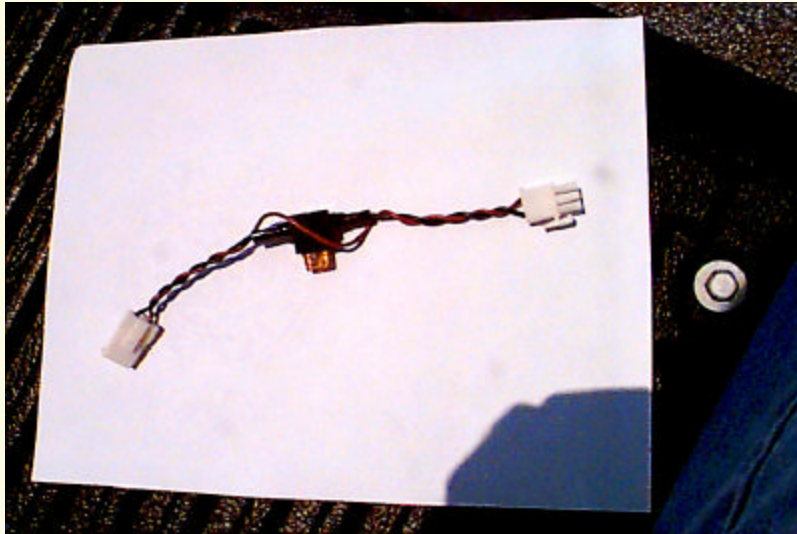
Inline fuses

4 We had a problem with some of the pumps failing and burning out the power supply. Andersen suggested installing this inline fuse to safeguard the power supply.

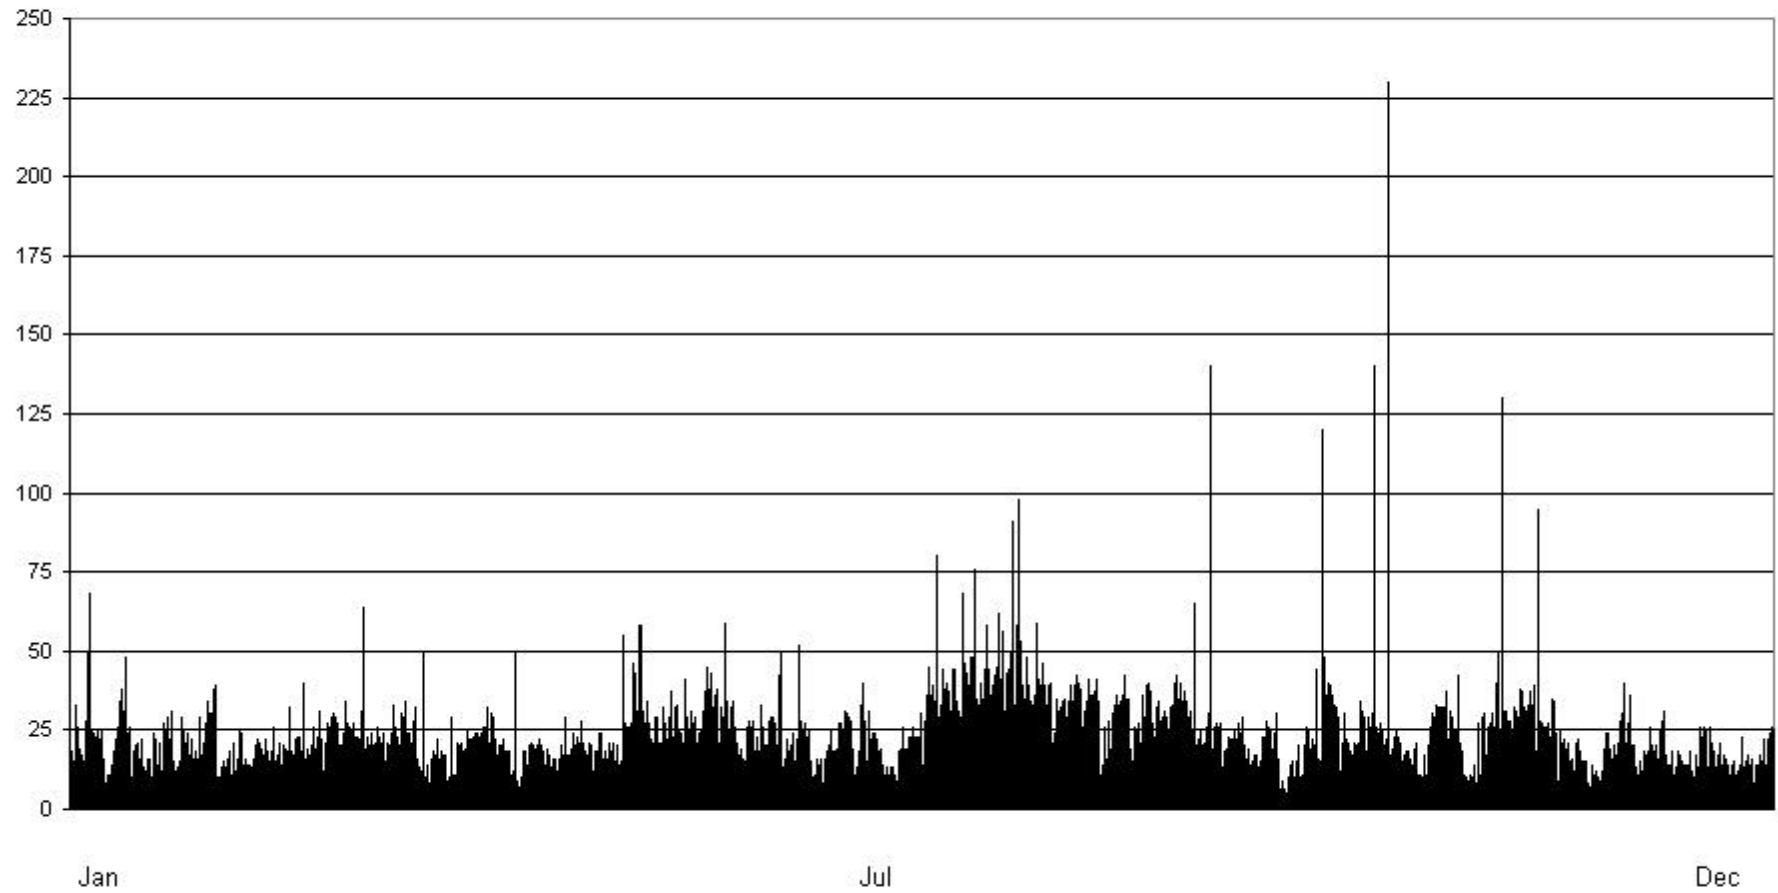
**GA PM 2.5 Data
All Sites Combined
(Chronologically)**
